Manhole Inspection Summary

Manhole # S3500_064MH

Location Address: **2329 CALVERT ST**

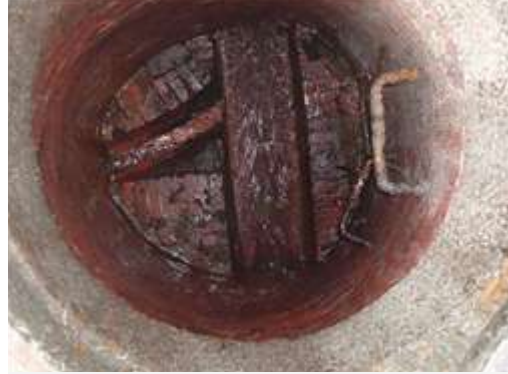
Top View

Corroded steps. Evidence of surcharge - Bench debris.

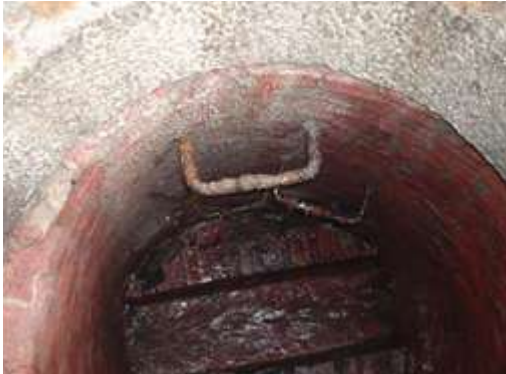
Defect

Frame Offset: **0** (in.) Condition: ☐ Sound ☐ Cracked ☒ **Leaks**

Condition: ☐ Sound ☐ Cracked ☐ Root Intrusion ☐ Loose Brick ☒ **Deteriorated**

Infiltration: ☐ None ☒ **Joint** ☐ Cracks ☐ Mortar ☐ Roots ☒ **Wall**

Frame leaks. Adjustment deterioration and infiltration.

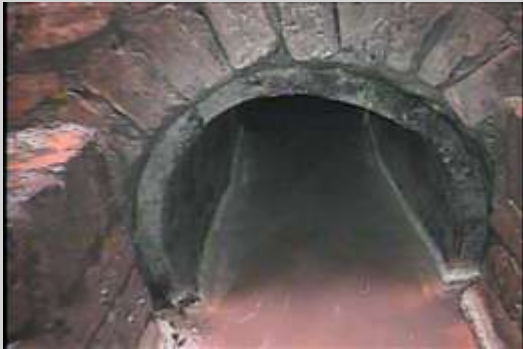
15 in. Circular Gravity Sewer Pipe Out @ 12 O'Clock

Deposits: ☐ None ☐ **Mud** ☐ Sludge ☐ **Debris** ☒ **Grease**

Infiltration: **Evidence** Pipe Seal Cond: **Unknown**

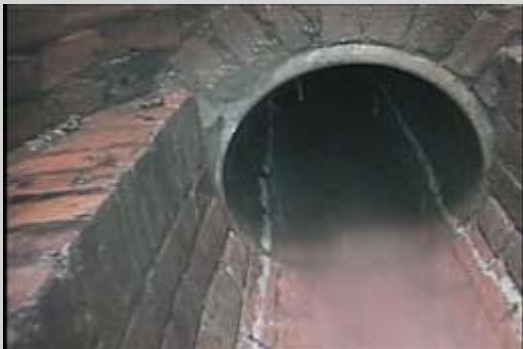
15 in. Circular Gravity Sewer Pipe In @ 6 O'Clock

Deposits: ☐ None ☐ **Mud** ☐ Sludge ☐ **Debris** ☒ **Grease**

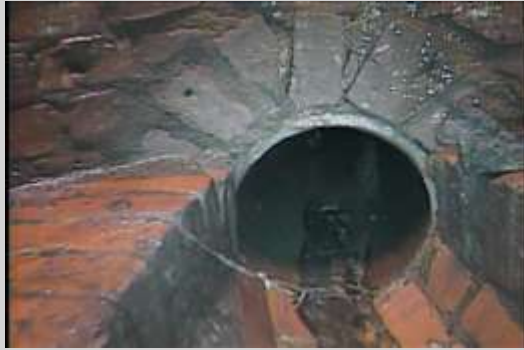
8 in. Circular Gravity Sewer

Deposits: ☐ None ☒ **Mud** ☐ Sludge ☒ **Debris** ☐ Grease
